An Arboricultural Report on Trees owned by

Ivybridge Council

At Victoria Park, McAndrews Field, Filham Park; Longtimber woods and the edge of the Erme running south from the woods; on detached land by Wadland Lodge; St Peter's Way; in Allotments and Cemeteries; land r/o Orchid Avenue and at Holman Way

August 2022

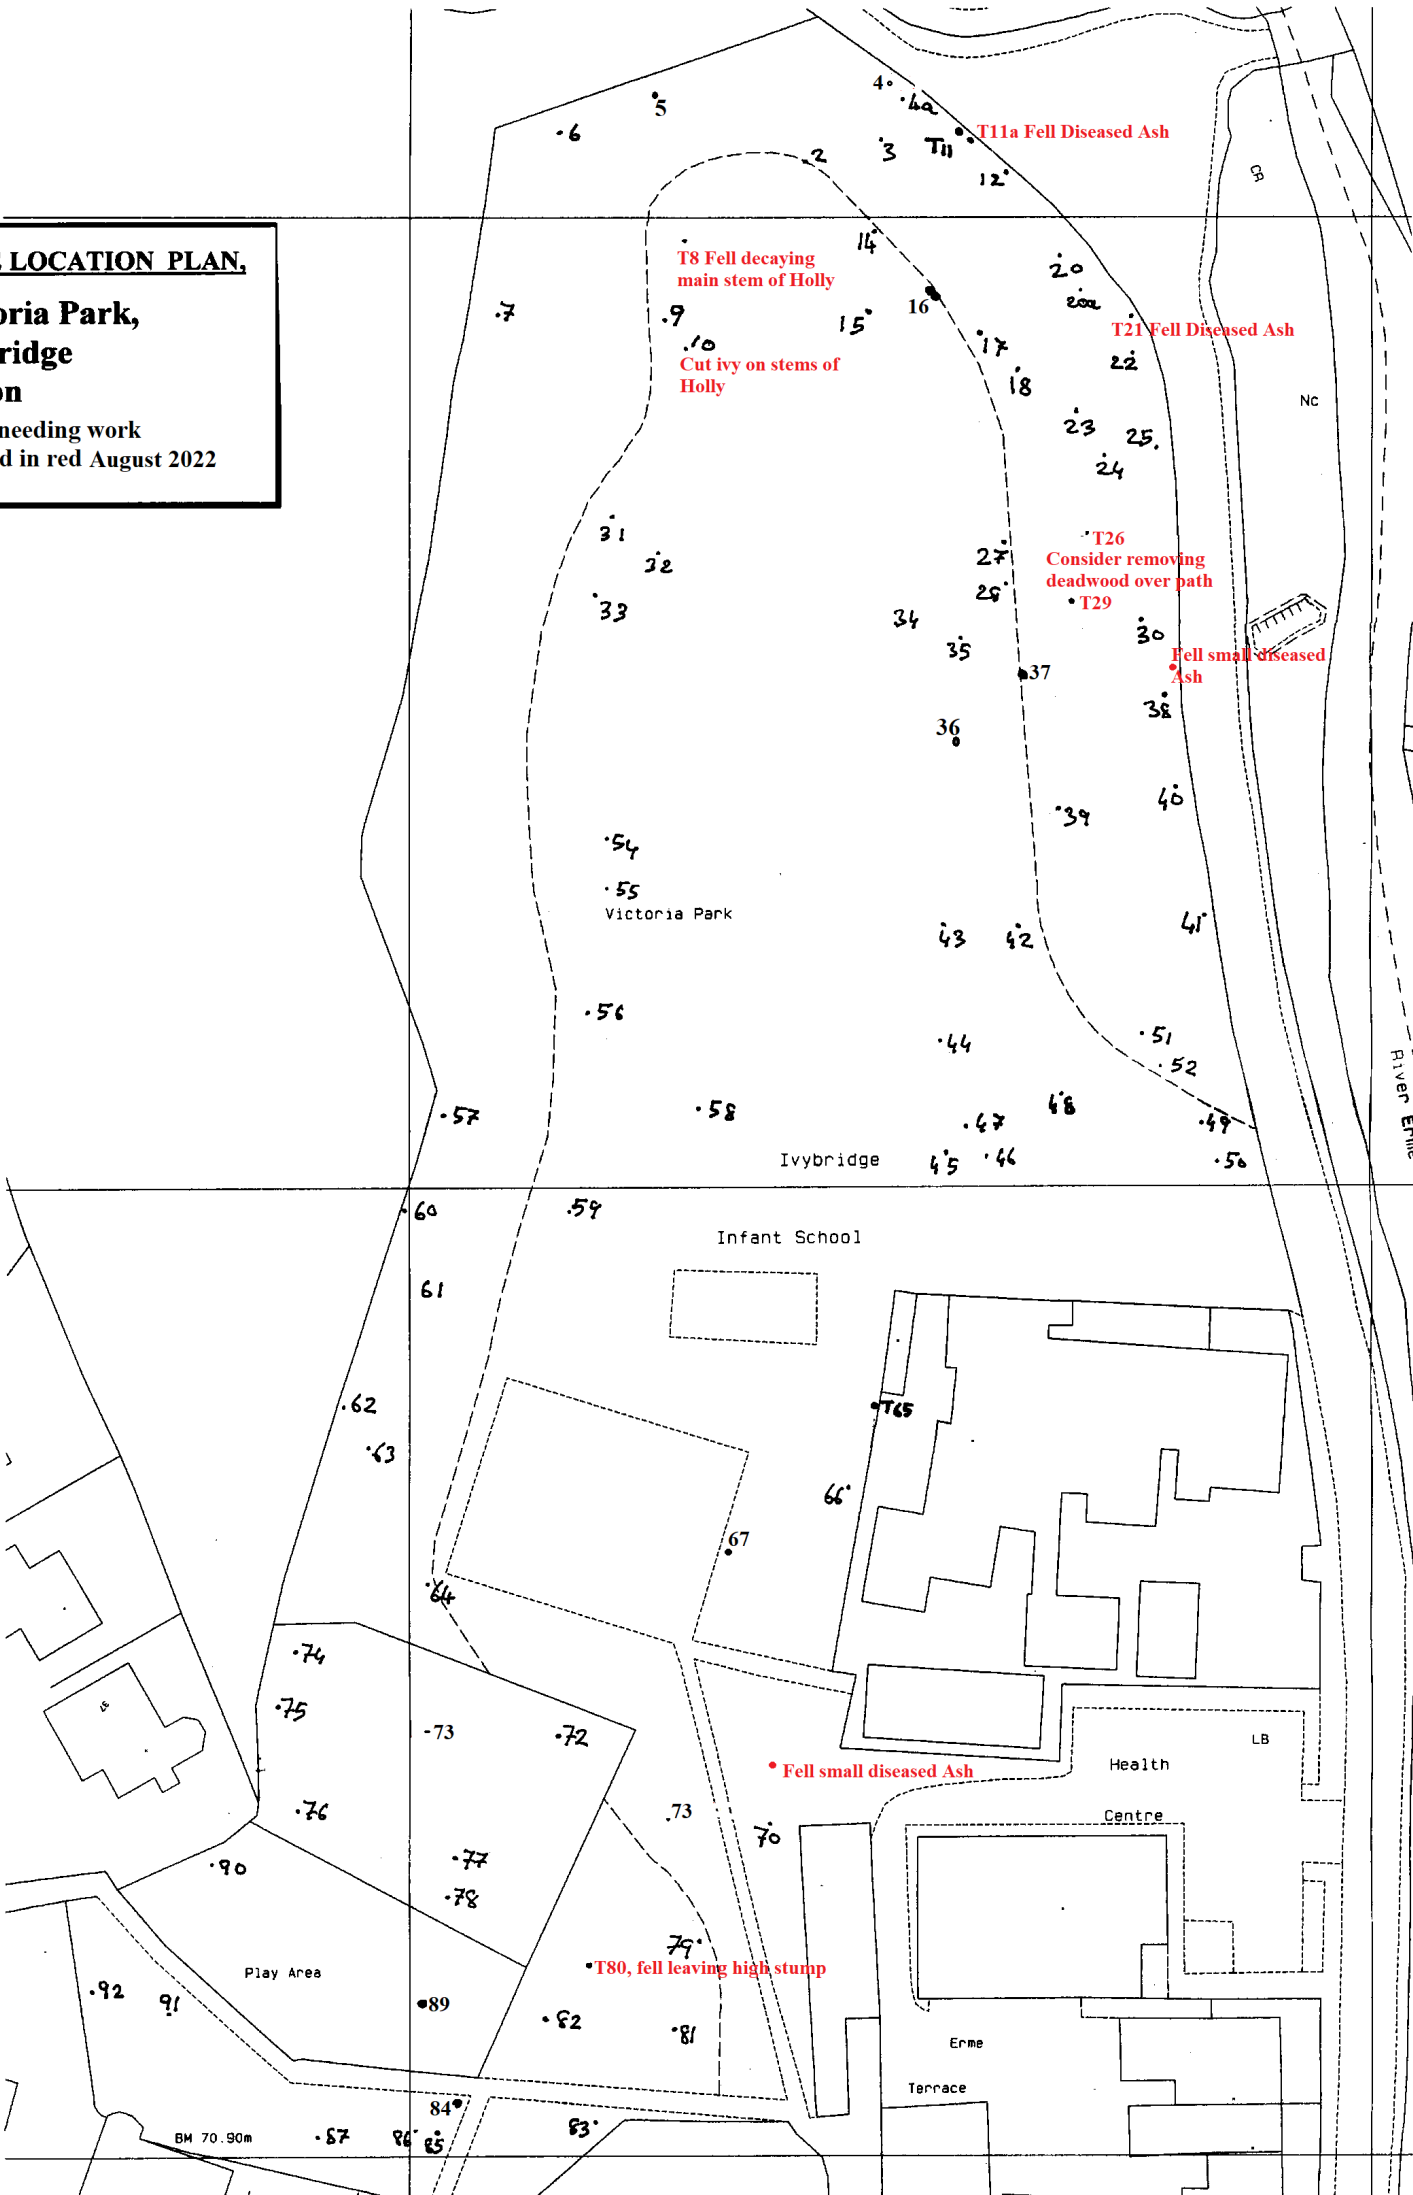
**Victoria Park,
Ivybridge
Devon**

Trees needing work
marked in red August 2022

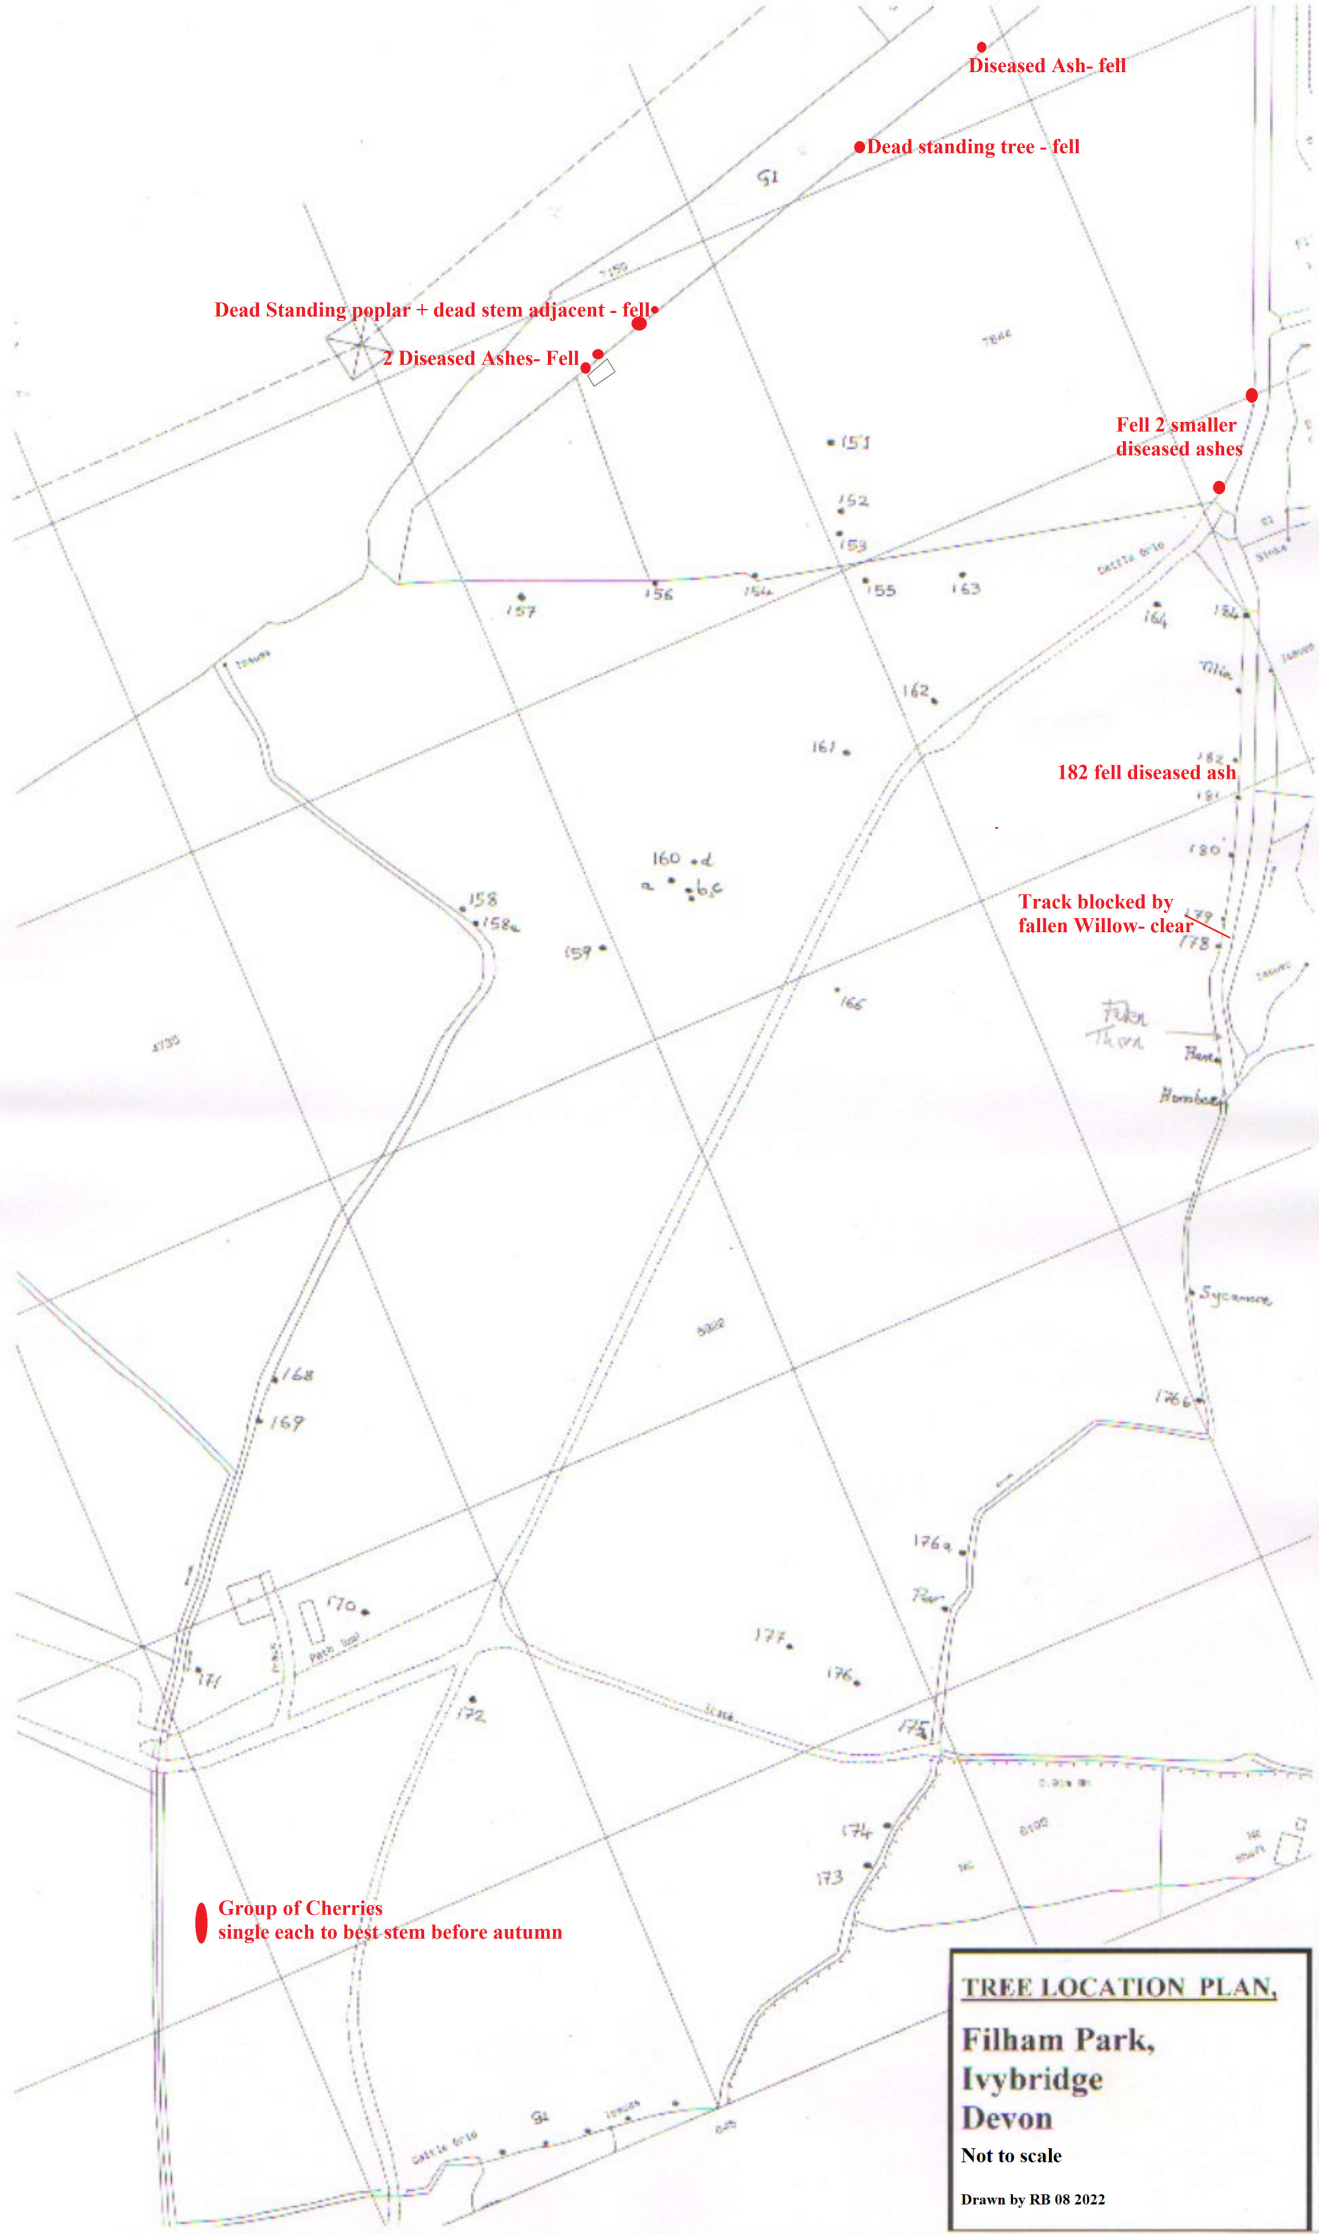
Notify owners of Wadland Wood as to the presence of several diseased Ash trees on their northern boundary, which pose a threat to users of the park, and should be felled.

Diseased Ash- fell

Dead standing tree - fell
